# Manhole Inspection Summary

Manhole # **S47G\_\_010MH**

Insp Date: **7/30/08 10:00 AM**

**Location** Address: **300 S Patterson Ave**

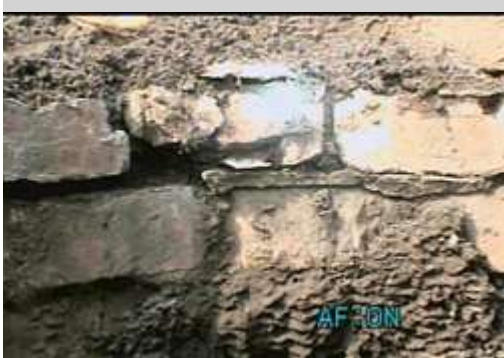
Defect 3

Condition: ☐ Sound ☐ Cracked ☐ Root Intrusion ☐ Loose Brick ☒ **Deteriorated**

Infiltration: ☐ None ☐ Joint ☐ Cracks ☒ **Mortar** ☐ Roots ☐ Wall

deteriorated, frame adjustment

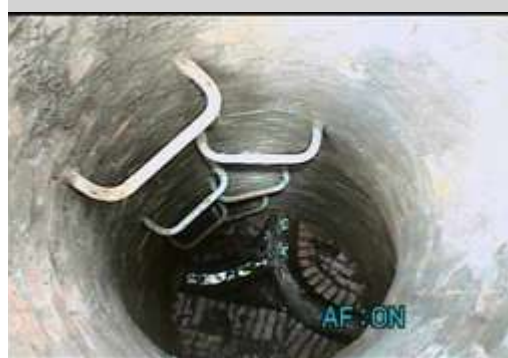
Defect 2

Count: **8** Missing: **0** ☒ **Corroded**

steps

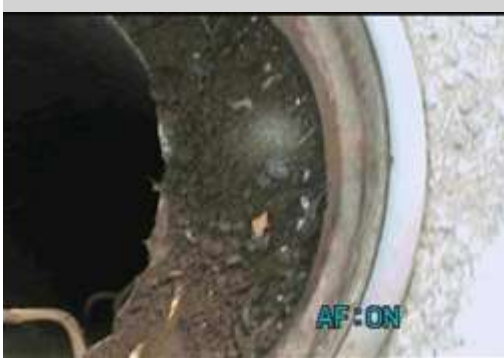
Defect 1

Offset: **6.5** (in.)

off set frame
